# Esthetic Restoration by Two Glass Ceramic Crowns Due To Failure of Porcelain Laminate Veneer on Discolored Maxillary Central Incisors: A Case Report

Saafi Jilani\*, Asbia Salem, Asiri Ahmad Yahia and Khribech Hager

Faculty of Dentistry, University of Monastir, Tunisia

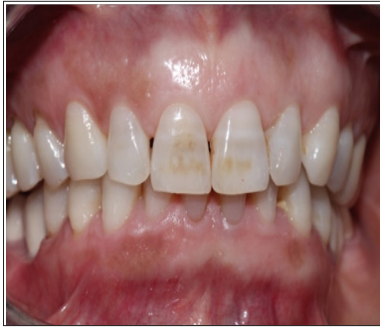
were vital and had no carious were detected. The anterior guide is functional with absence of posterior interferences, but the overbite was almost 4mm. She complained about stained maxillary central incisors (Figure 1) due to dental fluorosis. After clinical examination, radiographs, photographs, study casts (Figures 2-4) were performed.

**Figure 1:** Intraoral View: discolored maxillary central incisors teeth.

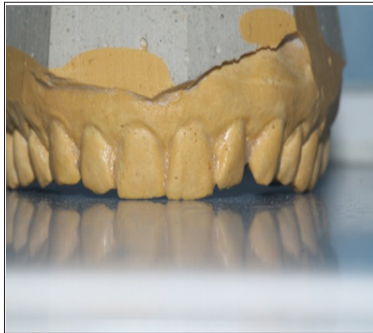
**Figure 2:** Study cast.

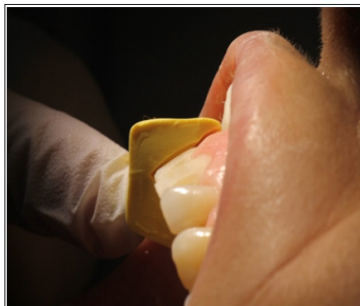
**Figure 3:** Index for reduction control.

Esthetic correction with glass ceramic lithium disilicate laminate veneers (IPSe. maxCAD, Ivoclar Vivadent) for maxillary central incisors was planned. The preparations were performed with diamond burs. Depth orientation grooves were placed on the facial surface of the tooth with 0.3mm and 0.5mm three wheel diamond depth cutter on the gingival one third and incisal two third respectively along the longitudinal axis of each tooth. The preparation margins were finished with diamond burs to perform a supra gingival chamfer. An incisal preparation was carried over the incisal edge from buccal to palatal, with up to 1.5 mm of incisal reduction. Preparation of the proximal area was stopped just short of the interproximal contact (Figure 5). The shade of maxillary teeth was selected using Vita 3D master. After gingival retraction (Figure 6), impression was made with polyvinylsiloxane by heavy body –light body combination (Figure 7). The temporary restoration was done with resin acryl using the silicone index. It was bonded to the teeth only at 2 to 3 spots with composite resin.

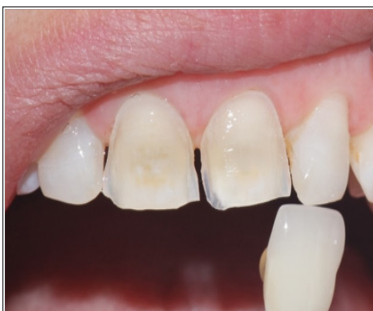
**Figure 4:** Shade selection.

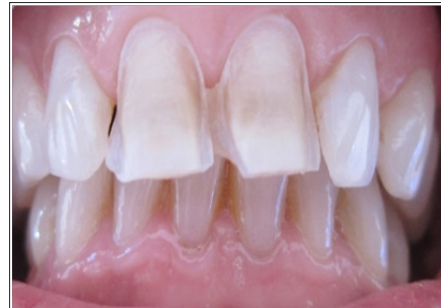
**Figure 5:** Final preparations.

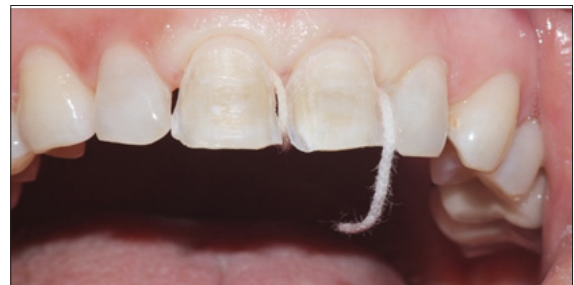
**Figure 6:** Gingival retraction.

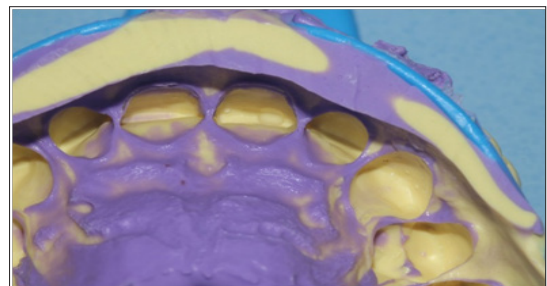
**Figure 7:** Impression.

In the lab the working cast was scanned and the laminate veneers were manufactured with computer-aided manufacturing after the step of computer-assisted design using CAD/CAM indirect technique.

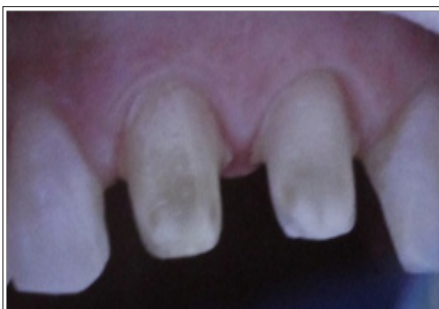
After two months, the patient came back and complained of debonding of the two veneers. After a thorough investigation she has informed us that the decementation was occurred by pen biting as a parafunctional habit not declared during the initial clinical exam. Esthetic correction with glass ceramic lithium disilicate crowns (IPSe. maxCAD, Ivoclar Vivadent) was Once more used for maxillary central incisors. Lithium disilicate crowns were indicated as all ceramic esthetic because they have been considered as a desirable restoration for a bi-layer crown due to its sufficient strength properties and more tooth-like appearance. The new decision was to change the protocol undertaken in the last preparations. The modifications were in favor of full coverages on #11 and #21 to ensure retention on behalf of the longevity of these restorations. The preparations were carried on with diamond bur with a finish line as a deep chamfer and respecting the shared preparation principles in the anterior for all systems (i.e., single-unit and FPD abutment) (Figure 8) [16]. It was extended to the proximal and lingual faces of the two central incisors.

**Figure 8:** Preparation for two glass ceramic crowns.

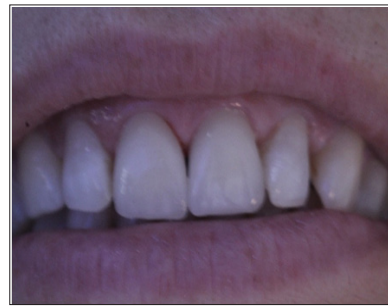
**Figure 9:** Cementation of two glass ceramic crowns.

Most CAD/CAM and copy milling systems recommend that the minimum axial wall reduction for anterior crowns is 1 mm to 1.5 mm. The total occlusal convergence angle can range between 4° to 6° (Figure 9). The interim crowns were performed with acrylic resin using the index and cemented with temporary cement. After final impression, the working cast was scanned and frameworks were manufactured using CAD/CAM indirect technique and tried in the mouth to check marginal fit, stability and the space left for cosmetic. After performing ceramic stratification in the lab, in the clinic glass ceramic lithium disilicate ceramic crowns were tried again to verify esthetic, occlusion relationship and cemented using dual cure adhesive cement.
