Antimicrobial Copper Effective in Major Urban Transit System

Citation: Kenneth Lu, Gary Ong, Nicolas Mendez, J Steven Rhodes. Antimicrobial copper effective in major urban transit system. Biomed J Sci & Tech Res 45(2)-2022. BJSTR. MS.ID.007179.

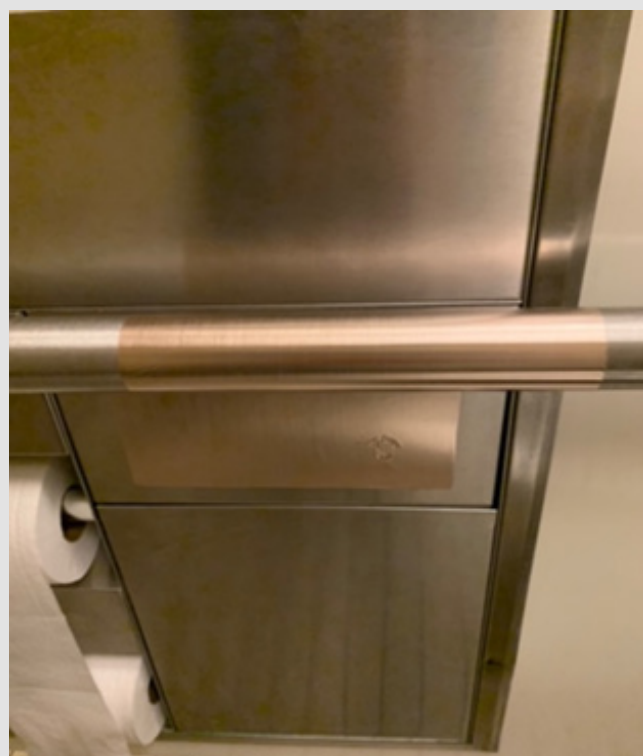
Figure 1: Antimicrobial copper on LA MTA bathroom handicap grab rail and trash receptacle door.

We adhered antimicrobial copper foils to stanchions, grab handles on a Los Angeles Metro bus and rail car, as well as to common touch areas in bathrooms and other public areas in the Los Angeles Metropolitan Transportation Authority headquarter for a pilot project to assess feasibility and antimicrobial property. Anti-Covid property of the copper was also assessed by the EPA and will be reported in a separate article. In the present publication, we focus on the anti-bacterial results of the pilot. This method of resurfacing touch areas offered some advantages to the alternative of refurbishing buses, rail cars and other areas, which would require taking the vehicles out of service for a period of time to disassemble existing stainless steel structures and reassemble with copper alloy parts. The copper alloys are usually not up to EPA registered antimicrobial standards [11], as they need to maintain rigidity. Cost of replacement and amount of copper is also very substantial. With thin foils, they only need to be customized to the shape and size of the surfaces and adhered, with savings in time, effort as well as cost.

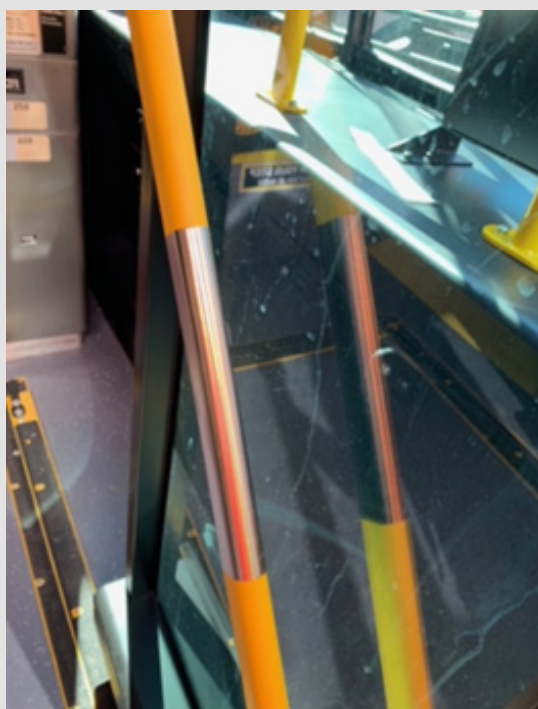
Figure 2: Antimicrobial copper on LA MTA bus entrance grab railing.

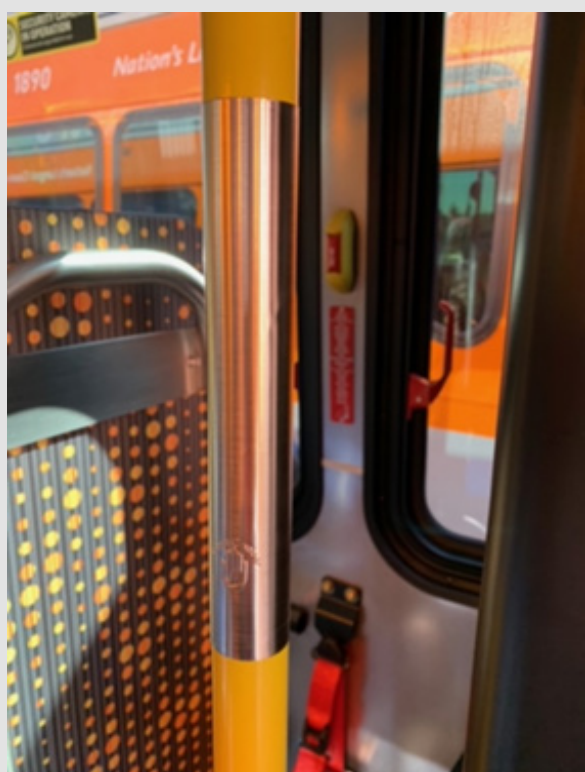
Figure 3: Antimicrobial copper on LA MTA bus stanchion.
